Southwest District Health Land and Facility Report

PREPARED FOR SOUTHWEST DISTRICT HEALTH
AUGUST 2025

LAND AND FACILITY REPORT

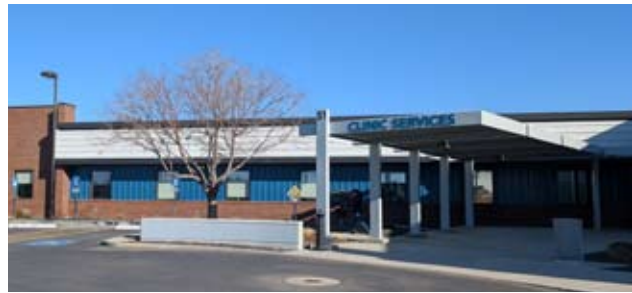
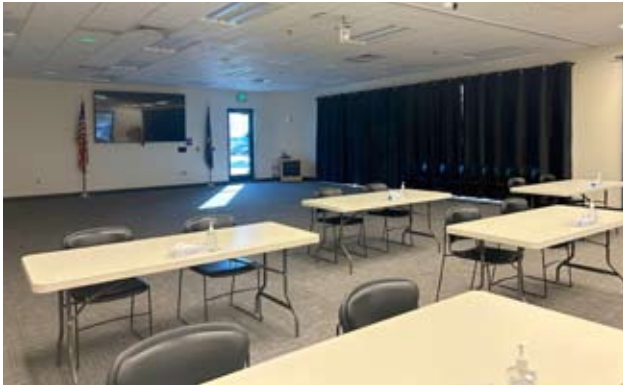
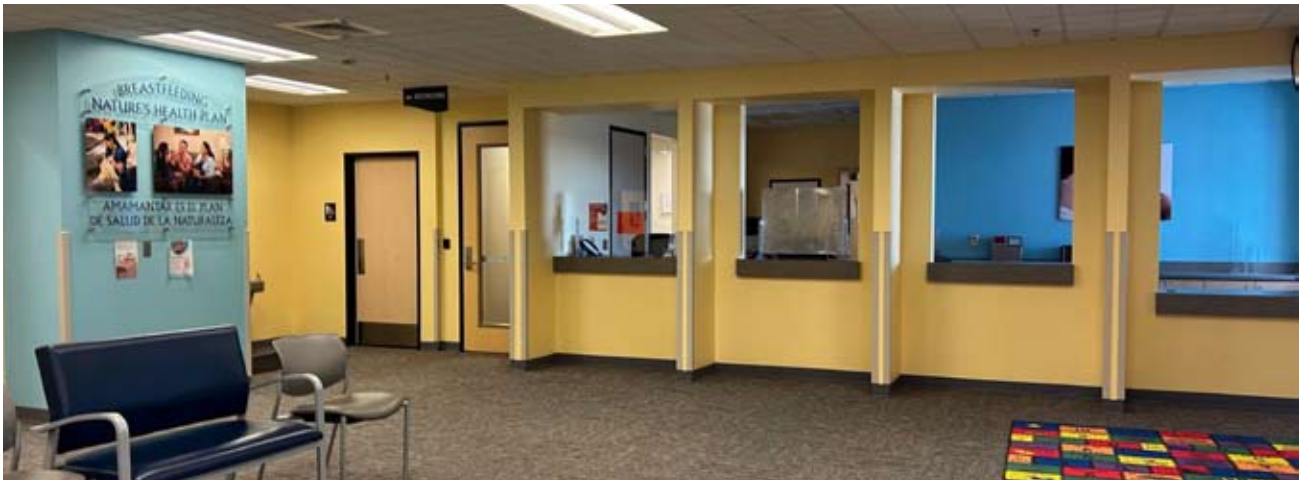
The Caldwell Office serves as Southwest District Health's main office. It houses all divisions, including Family and Clinic Services (FCS), Environmental & Community Health (ECH), and District Operation (DO) services. Built in 2009, the building is well maintained but does have minor maintenance needs.

The roofing membrane is nearing the end of its lifecycle and is recommended for replacement within about three years. Tree roots are damaging the parking lot curbs and pavement. It is advisable to evaluate overgrown trees for potential replacement, followed by repairing the impacted curbs.

The HVAC system uses individual heat pumps. Replacing failed units is labor-intensive, disruptive, and costly. While a centralized system would simplify maintenance, its cost-effectiveness is unclear. For now, repair when needed.

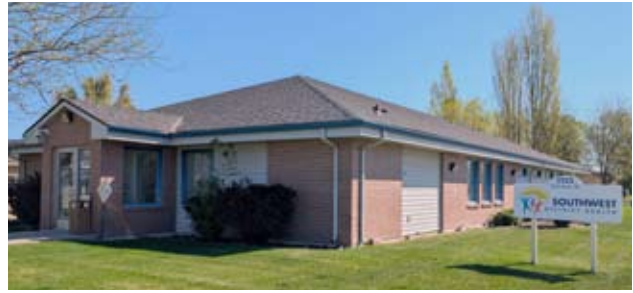
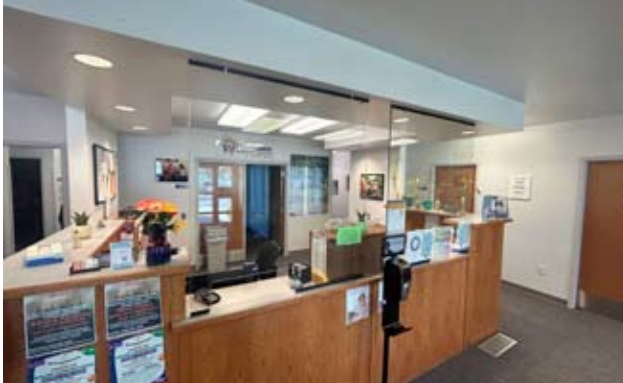
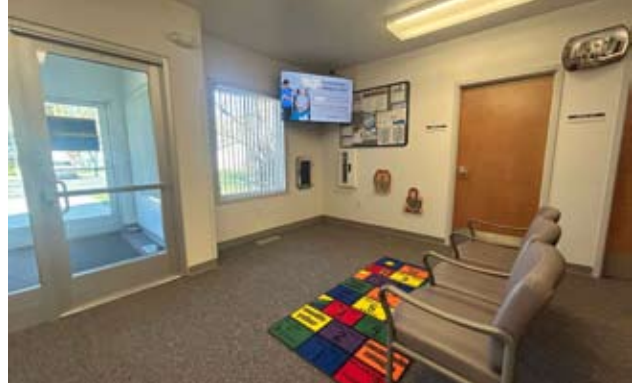
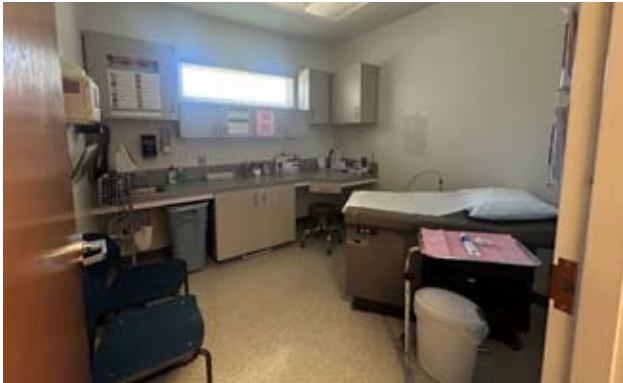
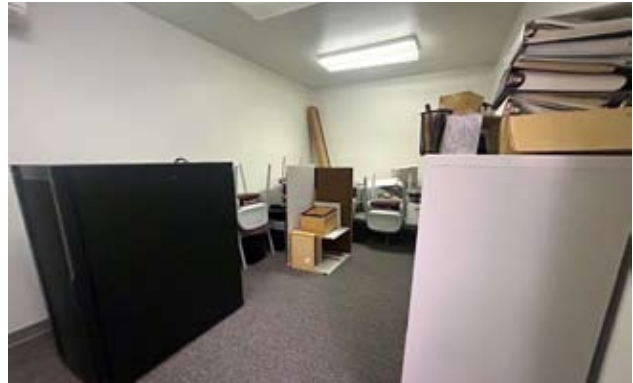
The Payette Office building is relatively new and in good condition. Water damage identified in November 2024 has been remediated. Downspout extensions are recommended to divert rainwater away from the foundation.

An automatic entrance door operator, while not required by ADA Code, would improve accessibility. Installing a speaker at the front reception desk could address sound transmission issues caused by the high counter and glass shield.

It is recommended to install IT infrastructure, such as monitors, speakers, and microphones, in the conference room to support hybrid meetings and community events.

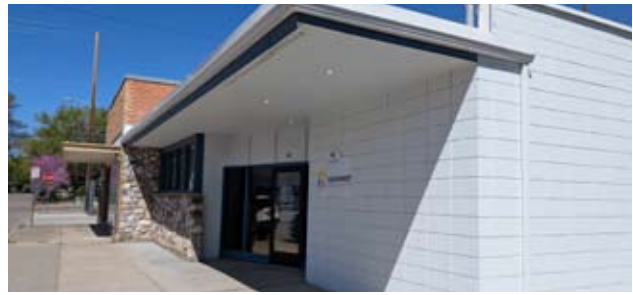
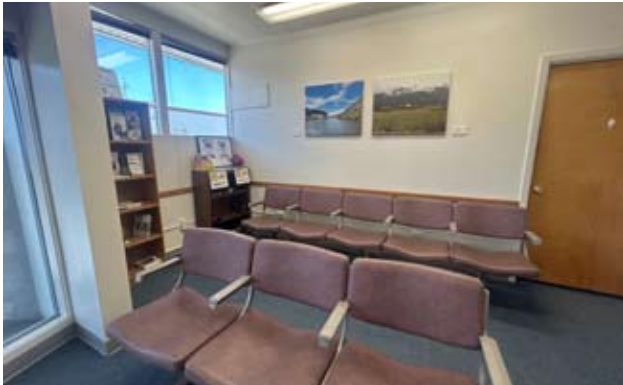
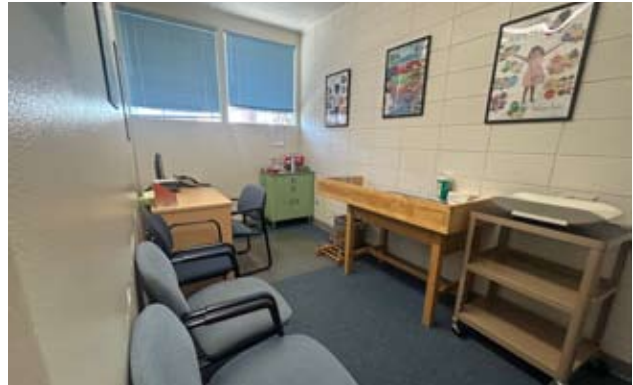
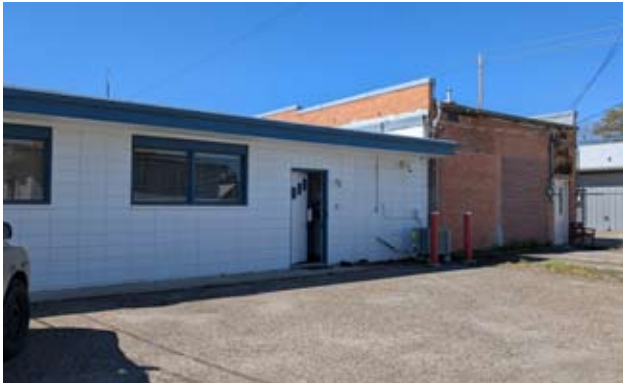
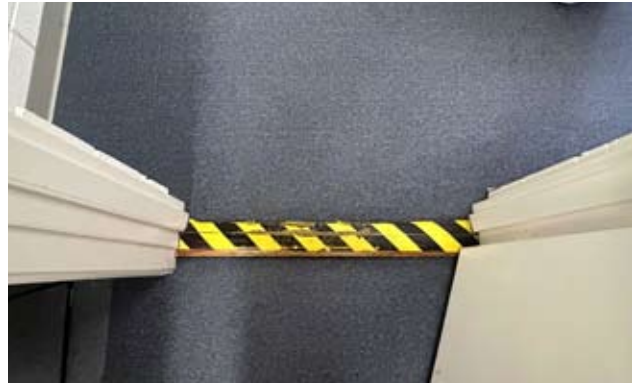
The office, located in downtown Weiser, offers easy public access and visibility. The building shares a concrete block wall on the west side with an adjoining chiropractor's office, while the east side includes an alley that leads to a gravel staff parking lot at the rear of the building. Public parking is available on the street, but no designated ADA-compliant spaces. Additionally, there is a two-stall garage behind the building for storage of emergency preparedness equipment, such as tables and tents.

The town of Weiser experiences periodic power outages several times annually. Due to budget constraints, the office does not have a generator; instead, it coordinates with the local hospital for immunization storage during outages.

Several ADA compliance issues are present, including the absence of accessible parking, inadequate transaction counter height at the reception desk, and threshold violations. While not required by ADA code, an entrance door operator would be very beneficial for all users. There is also evidence of ceiling leak damage in the mechanical storage area.

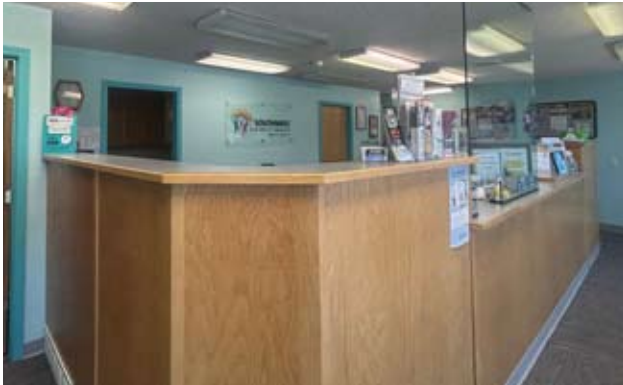
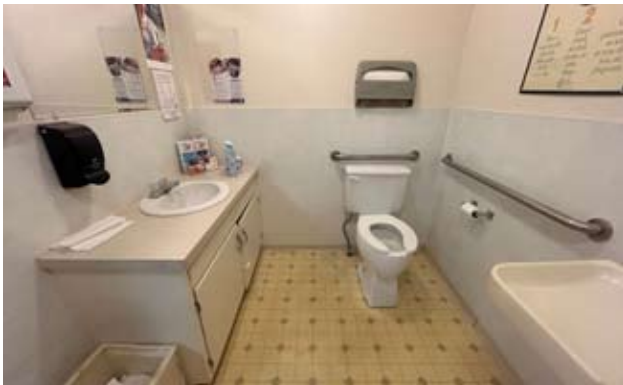
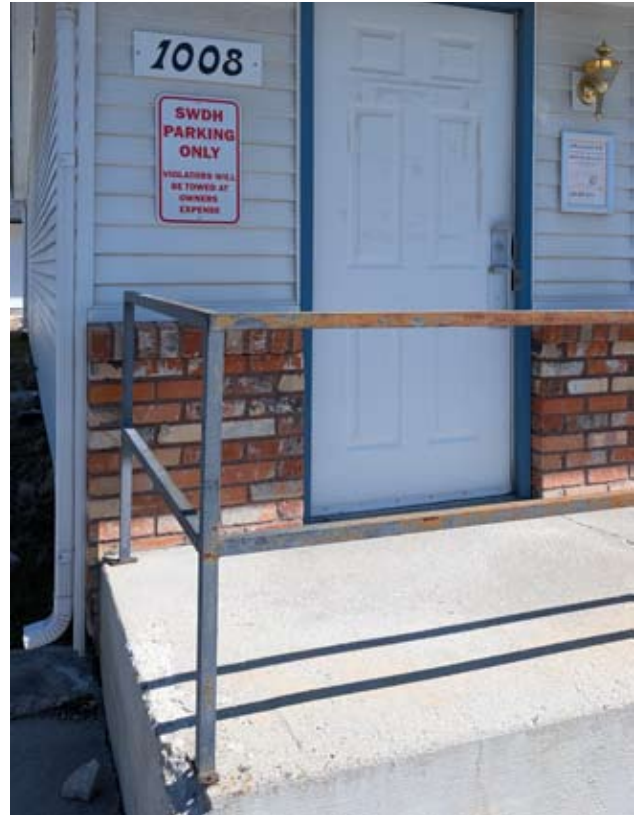
The Emmett Office building requires several maintenance improvements to ensure its safety, ADA accessibility, and long-term functionality. The small bathroom with the furnace closet requires flooring repairs due to past water damage.

The railing on the front entrance ramp is loose and requires immediate repair. This entrance ramp is wide enough for ADA standards, but it does not comply with the International Building code. Per [2021 IBC Chapter 10, Section 1012](#), ramp guardrails must have openings no larger than 4 inches, handrails on both sides, and edge protection. The landing at the front door must also be at least 60 x 60 inches. It is recommended that the entrance ramp be replaced. Additionally, installing a push-button door operator could improve accessibility for individuals using wheelchairs or strollers.

The rear stairs and railings are deteriorating and need repair. Roof replacement is expected in four to five years. The reception desk counter is too high for ADA compliance. ADA accessibility issues remain and require attention. Overall, the building has been well maintained and is in good shape for its age. It functions as needed and is conveniently located.
